Critical Evaluation of the Motorola M12+ GPS Timing Receiver vs. the Master Clock at the United States Naval Observatory, Washington DC.

Abstract

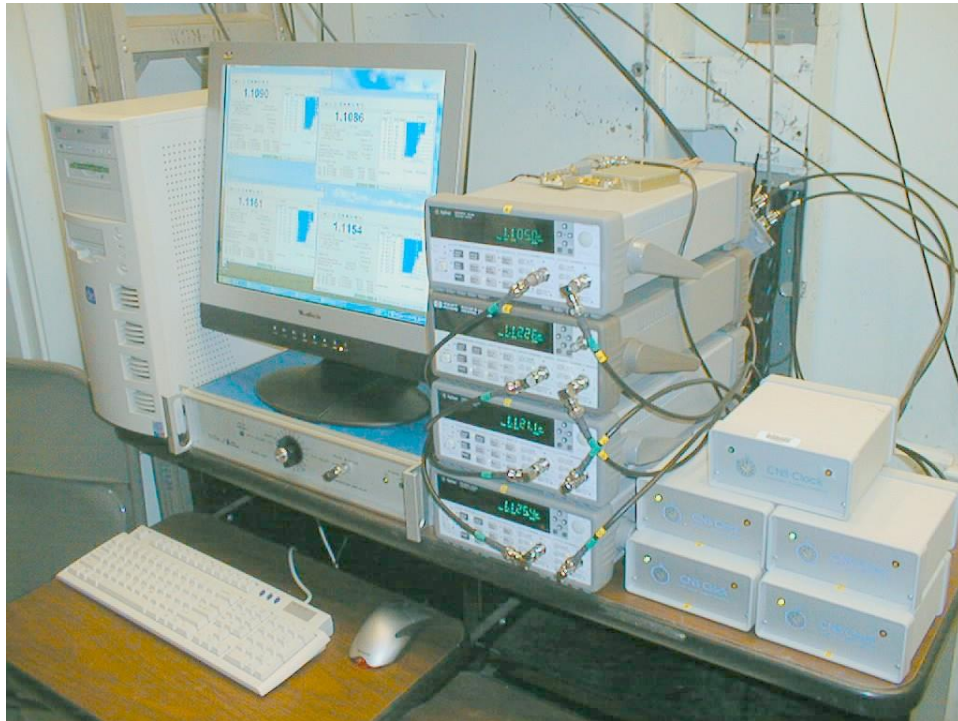
Figure 1: The CNS Test Bed

The Test Bed can be seen in Figure 1. Data collection was anticipated to be about 10Mb per day. The computer also simultaneously collects data from four TICs and interface with four GPS receivers using eight serial ports. This requires a high performance Personal Computer with plenty of disk storage, eight high performance serial ports, and fast enough to run four copies of the Tac32Plus software and respond quickly to many interrupts.

The CNS Test Bed has been developed to perform calibration and testing of any GPS timing receiver that produces a one-pulse-per-second (1PPS) output. To get a representative sample of receiver data, the test bed is sized to simultaneously test four receivers. The architecture is an extension of the master clock monitoring facility developed for NASA's Very Long Baseline Interferometry (VLBI) Geophysical Observatory sites around the world. It is based on the use of a Time Interval Counter (TIC) coupled with a computer that controls the GPS receiver module and performs data collection, reduction, statistical computations and logging.
